Subject: May 13, 2014 CWA Compliance Evaluation Inspection

**CWA COMPLIANCE EVALUATION INSPECTION REPORT
U.S. ENVIRONMENTAL PROTECTION AGENCY, REGION 5**

Facility: Imperial Marble Corporation
327 East LaSalle Street
Somonauk, Illinois 60552
41.630716, -88.678245

Date of Inspection: 5/13/2014 – 5/14/2014

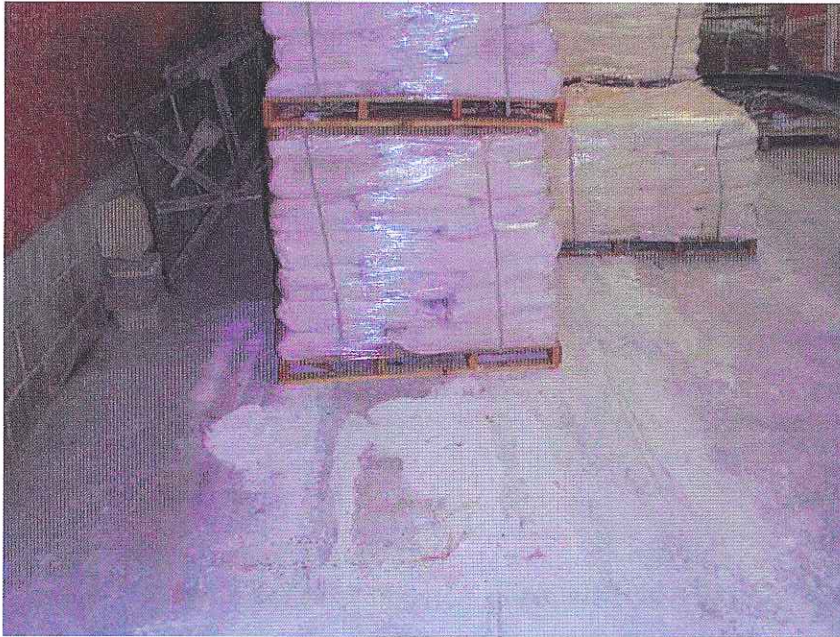
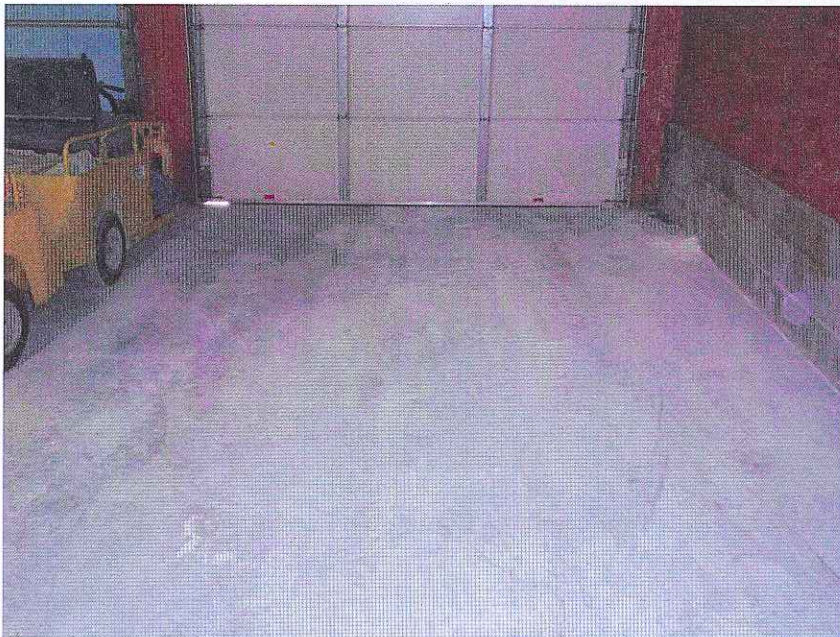
On the southeast corner of the facility, I observed an out building used to store raw materials (Photo P1010305, P101306). I observed a drain in the concrete pad on the north side of the out building. This drain's outlet is located immediately to the east of the pad. There was some track out visible on the north side of the out building (Photo

P1010305 Description: Raw materials stored in out building. Note material on ground with potential to cause track out and storm water contamination. Location: Out building. Direction: South. Date: 5/14/2014

P1010306 Description: Raw materials stored in out building. Note material on ground with potential to cause track out and storm water contamination. Location: Out building. Direction: North. Date: 5/14/2014

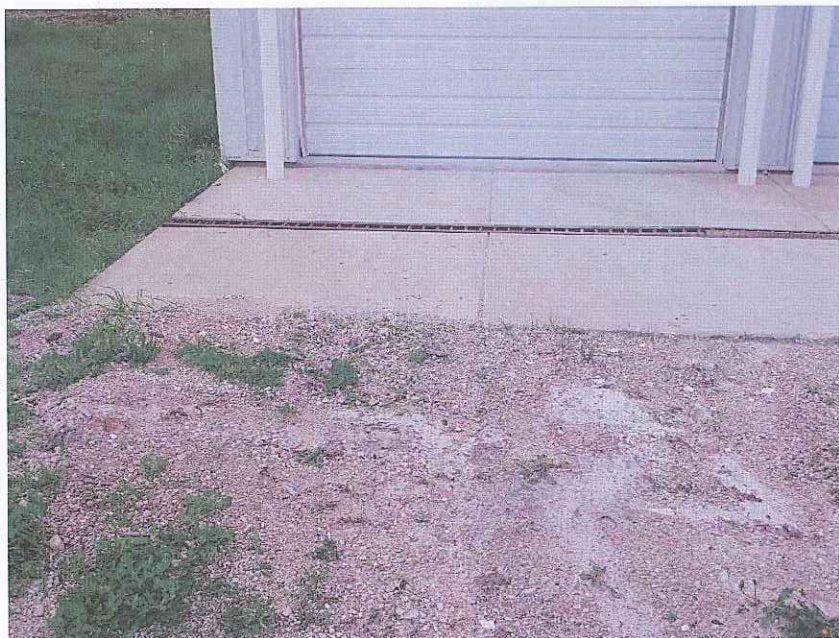
P101307). Storm water from this are flows to the storm drain on the east side of the parking area.

P1010307 Description: Concrete pad on north side of out building. Note slight track out and drain set in pad. Location: Northside of out building. Direction: South.
Date: 5/14/2014

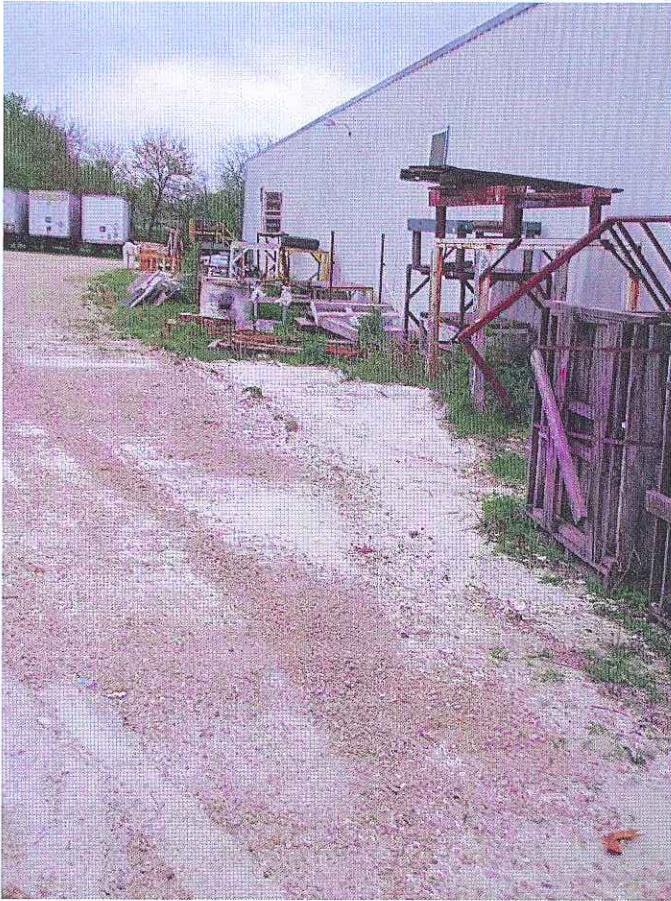
I observed an outdoor storage area on the south side of the main plant (Photo P1010257). I observed a white residue on the ground around the outdoor storage area. This area drained to the south. There was a roll-off dumpster filled with used barrels located south of the main plant and west of the out building (Photo P1010264). I observed that the bottom of the dumpster was rusted through and that there was the potential for precipitation to come in contact with the contents of the dumpster and then flow to the storm drain located in the grassed area south of the main plant (photos P1010265, P10267, P1010260, P1010258).

P1010257 Description: Outdoor storage area on south end of main plant.
Location: Southeast corner of main plant. Direction: Facing west. Date: 5/13/2014

- 5) A source of potential storm water contamination observed during the inspection was the outdoor storage area. The SWPPP states that "Whenever possible, any scrap steel, metal drums, and miscellaneous metal parts will be stored under structures to prevent extended contact with storm water runoff."

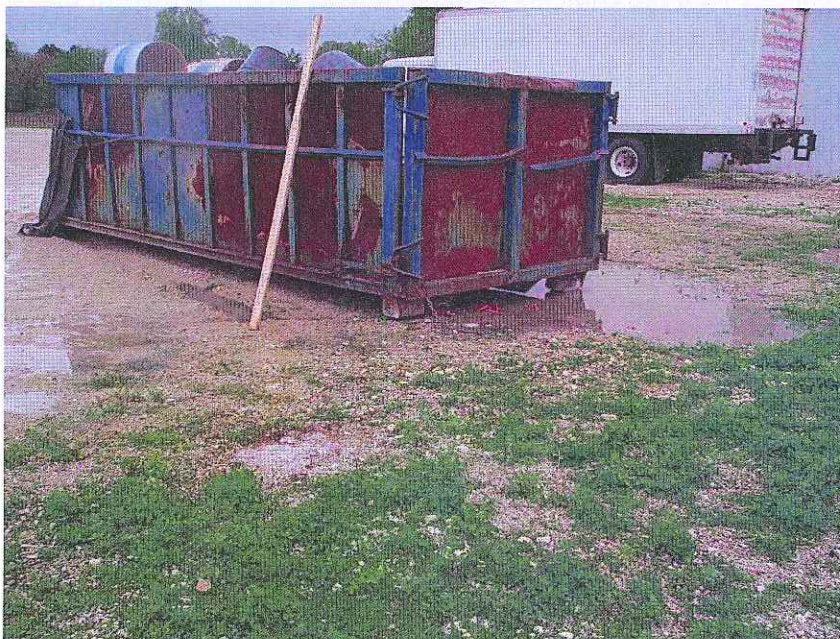
P1010264 Description: Roll off dumpster with empty barrels.
Location: West of out building. Direction: Northwest. Date: 5/13/2014

- 4) A source of potential storm water contamination observed during the inspection was from non-covered dumpsters. The SWPPP states that "Covers or tarps for the dumpsters will be investigated and options for enclosure will be evaluated." There was no evidence that this investigation was completed.

On January 22, 2016, I spoke with Mr. Chad Cartwright, Plant Manager. Mr. Cartwright informed me that since the inspection IMC has resumed all monthly, quarterly, and annual inspection. Mr. Cartwright sent me that last three months of inspection reports. Mr. Cartwright also stated that for the sampling requirement of the quarterly observations of event discharges, IMC has sampled at the outfall of the storm water collection system. Mr. Cartwright provided copies of the last three quarterly sampling. Additionally Mr. Cartwright informed me that they had added SWPPP training to the employee's annual training. Mr. Cartwright stated that IMC has moved as much of the equipment that was stored in the outdoor storage area to indoor storage areas or under cover as possible. He also stated that IMC has put covers over all dumpster.

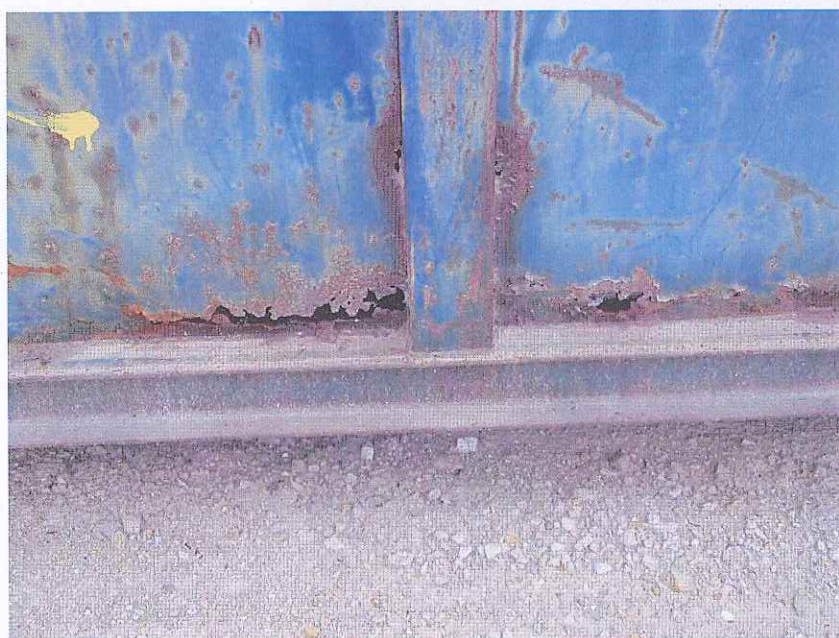
P1010265 Description: Holes rusted through bottom of roll off dumpster.
Location: West of out building. Direction: NA

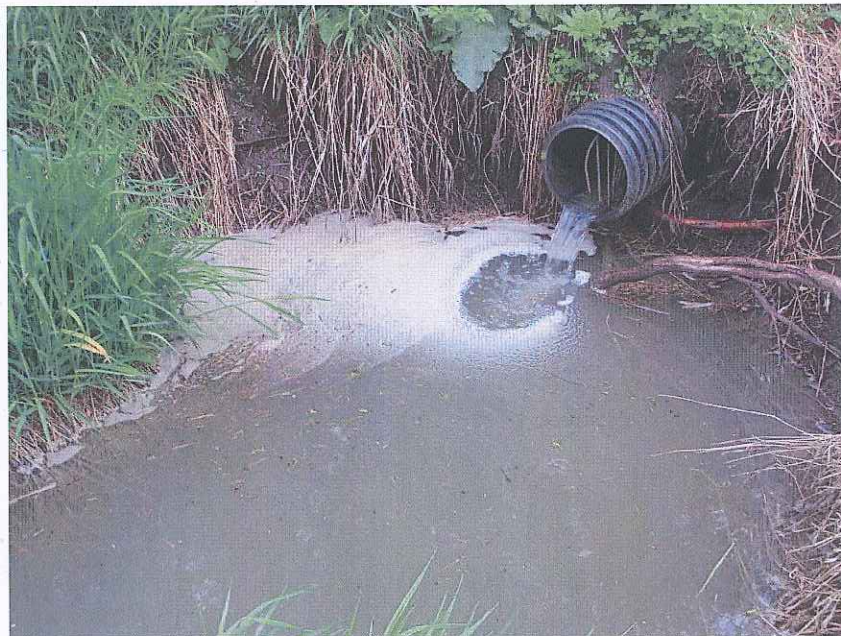
I walked to the outlet of the storm water drains located at the storm water retention pond south of the facility (Photo P1010294, P1010295, and P1010296). I observed an off-white foam on the surface of the water immediately at the outlet (Photo P1010297).

P1010294 Description: Outfall of storm water collection system.
Location: East side of storm water retention pond. Direction: North.
Date: 5/13/2014

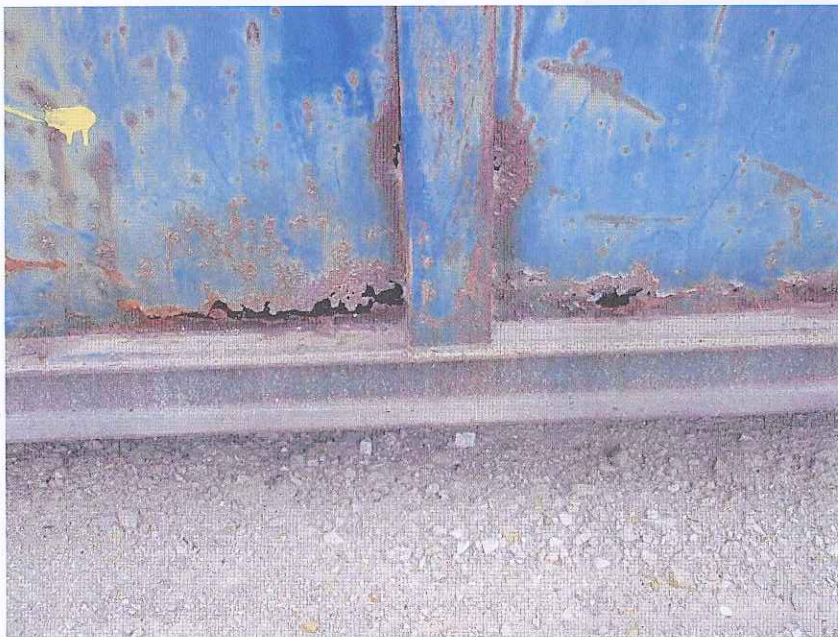
26: P1010265 Description: Holes rusted through bottom of roll off dumpster.
Location: West of out building. Direction: NA

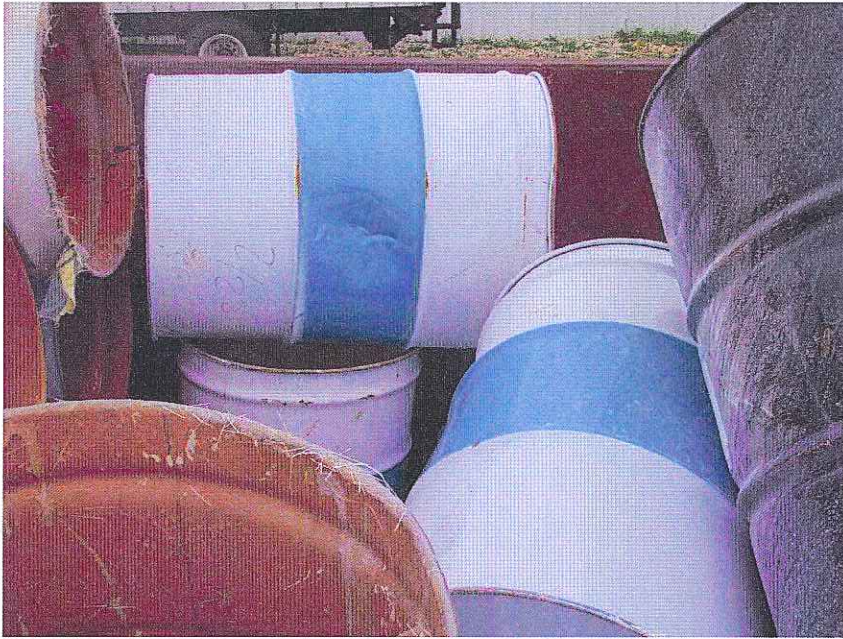
27: P1010266 Description: Contents of roll off dumpster. Note open uncovered used barrels.
Location: West of out building. Direction: East. Date: 5/13/2014

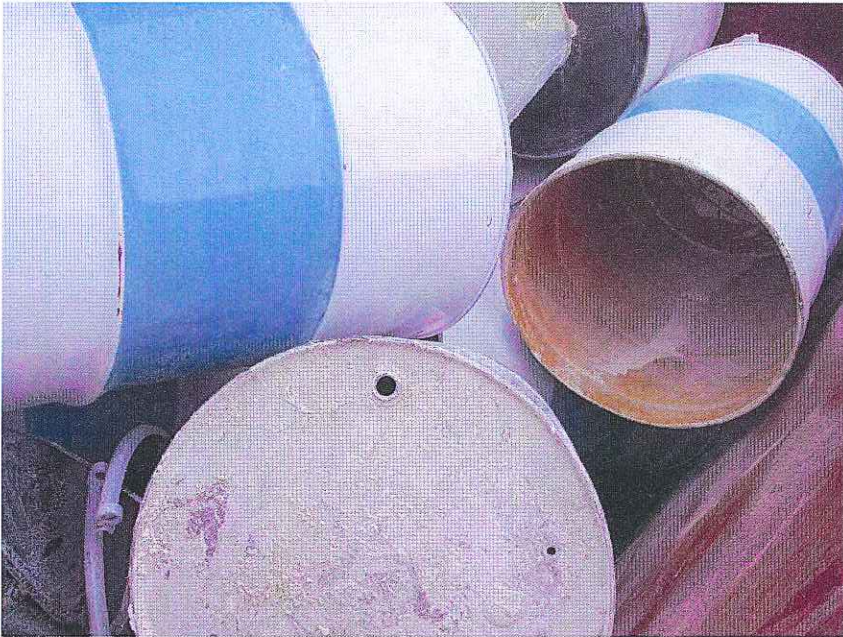
28: P1010267 Description: Contents of roll off dumpster. Note open uncovered used barrels.
Location: West of out building. Direction: South. Date: 5/13/2014

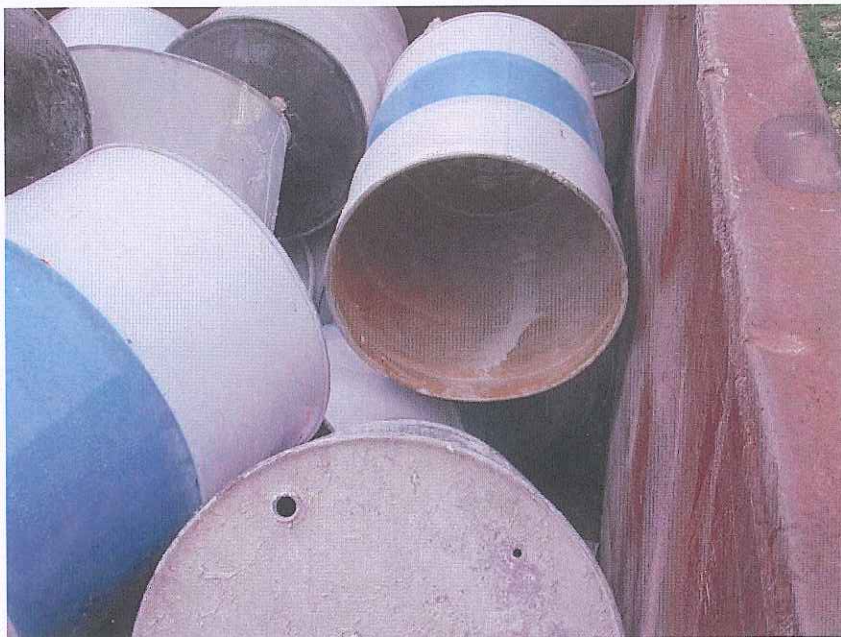
29: P1010268 Description: Contents of roll off dumpster. Note open uncovered used barrels.
 Location: West of out building. Direction: South. Date: 5/13/2014

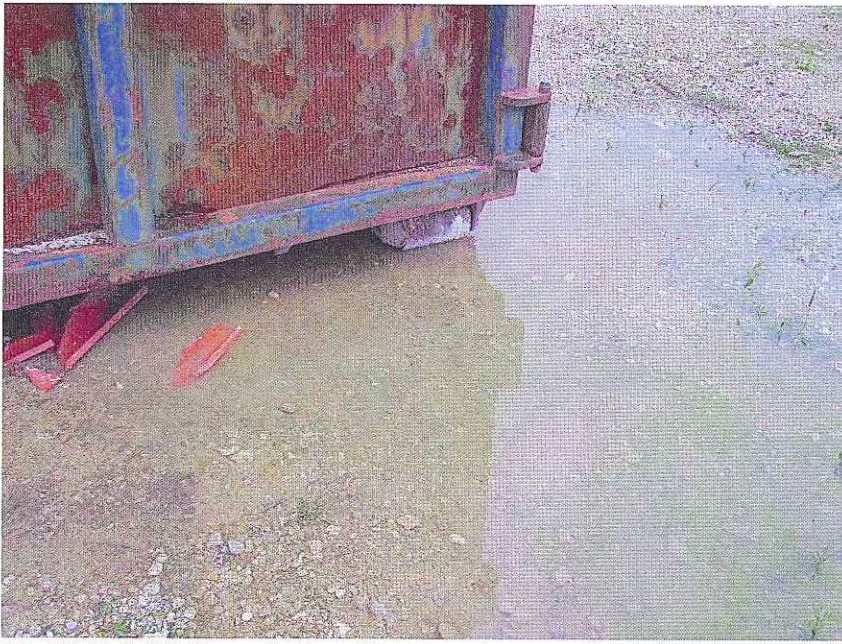
31: P1010270 Description: Storm water accumuliong around roll off dumpster
Location: West of out building. Direction: Northeast. Date: 5/13/2014

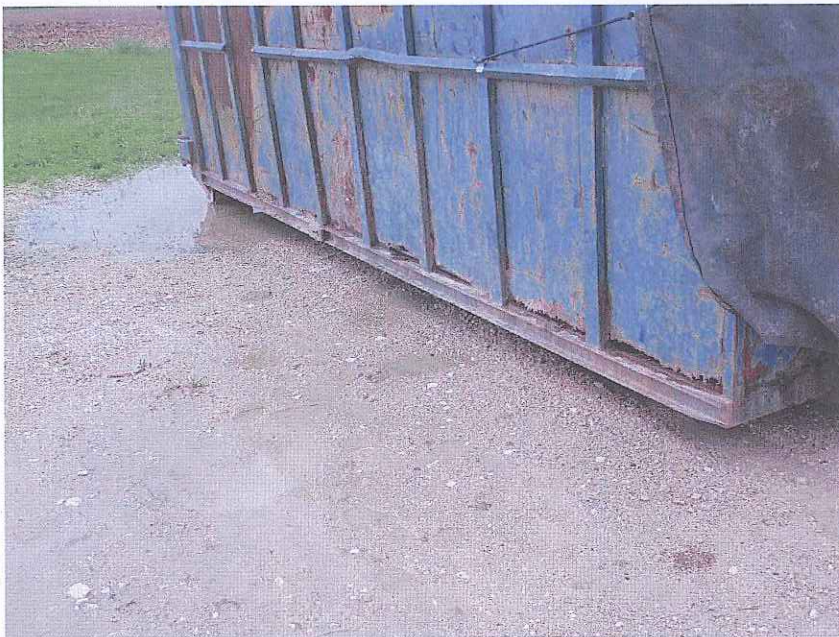
33: P1010272 Description: Holes rusted through bottom of roll off dumpster.
 Location: West of out building. Direction: South. Date: 5/13/2014

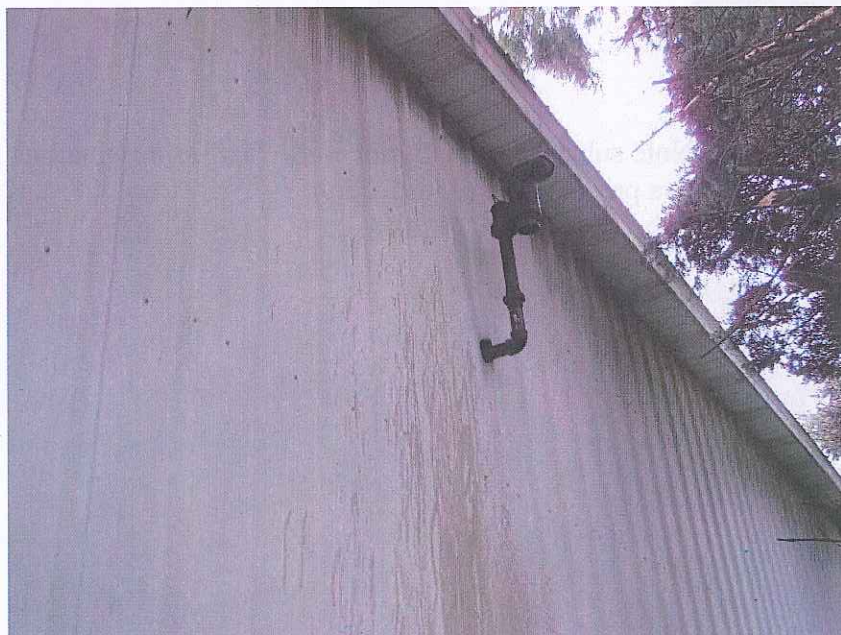
62: P1010301 Description: Vent from resin storage area. Note substance on exterior wall. IMC representative stated that this was caused by an isolated back up a few years prior to date of inspection.
Location: Northwest side of main plant. Direction: South. Date: 5/14/2014

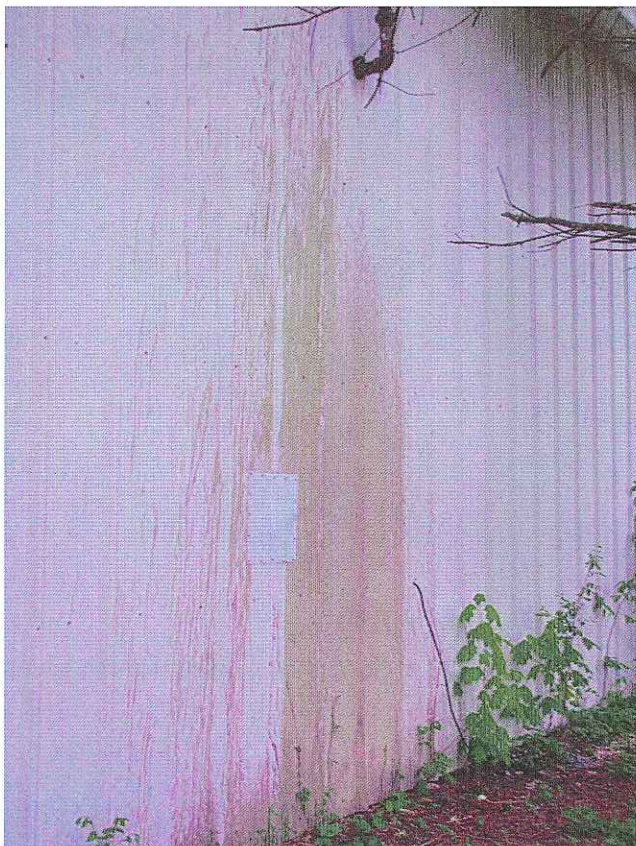
63: P1010302 Description: Vent from resin storage area. Note substance on exterior wall. IMC representative stated that this was caused by an isolated back up a few years prior to date of inspection.

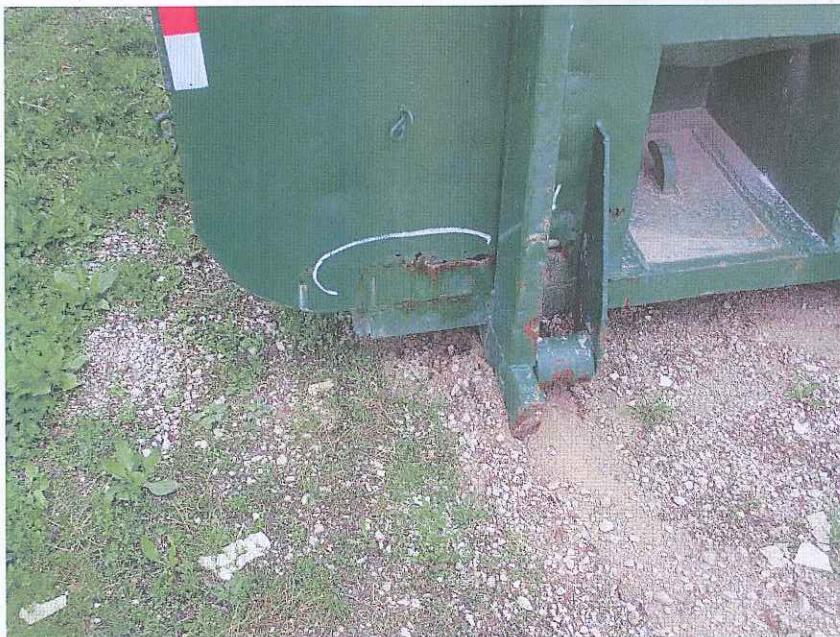
65: P1010304 Description: Rusty holes and potential source of storm water contamination in dumpster.
Location: West of west loading dock. Direction: South. Date: 5/14/2014

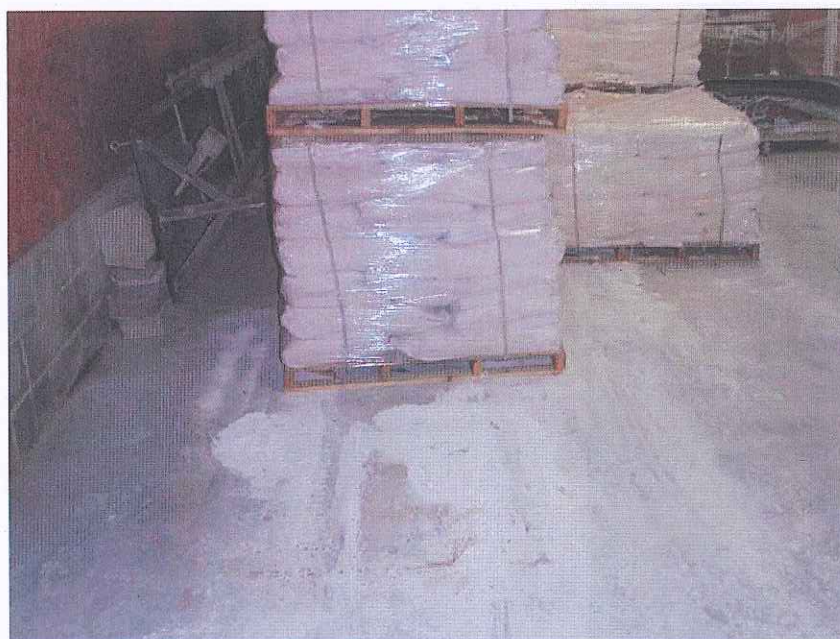
66: P1010305 Description: Raw materials stored in out building. Note material on ground with potential to cause track out and storm water contamination.
Location: Out building. Direction: South.
Date: 5/14/2014

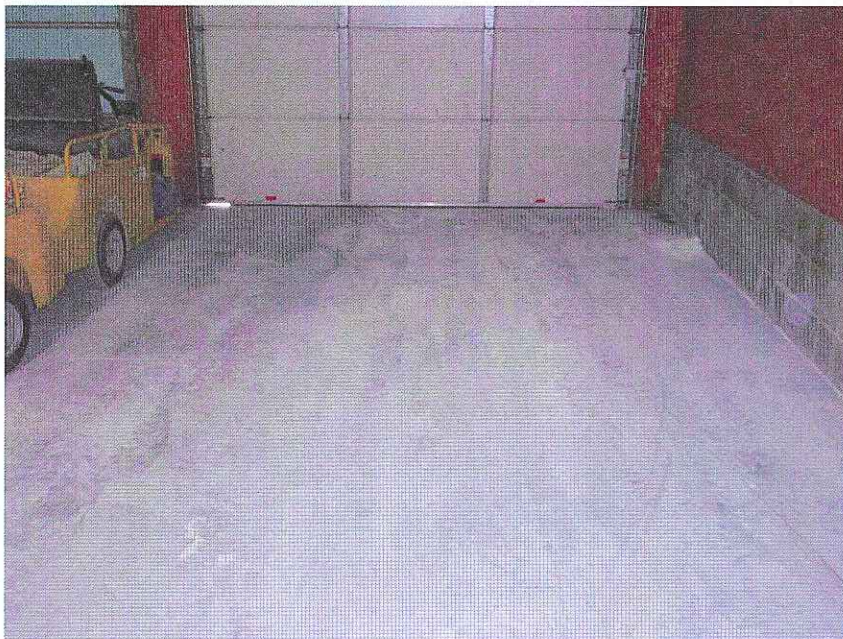
67: P1010306 Description: Raw materials stored in out building. Note material on ground with potential to cause track out and storm water contamination. Location: Out building. Direction: North.
Date: 5/14/2014

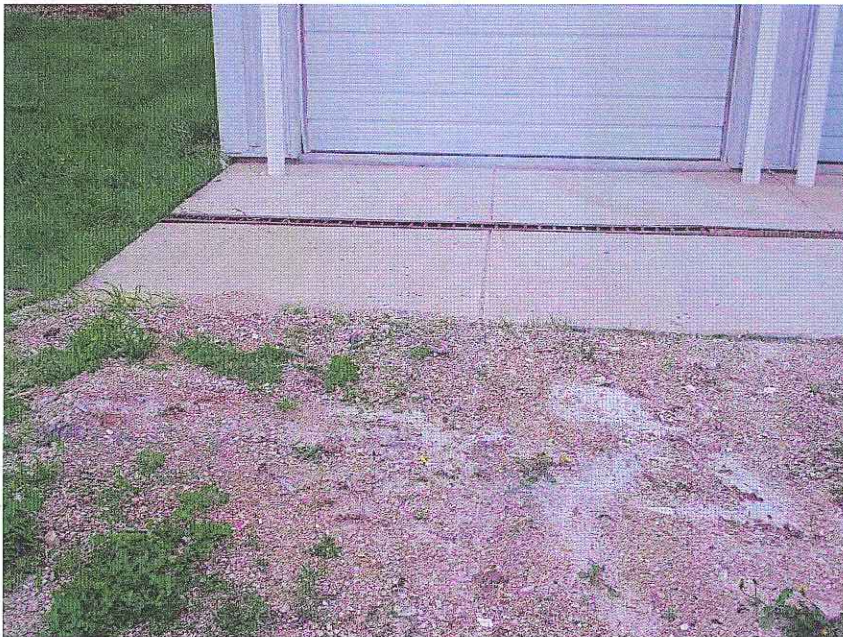
68: P1010307 Description: concrete pad on north side of out building. Note slight track out. Location: Northside of out building. Direction: South. Date: 5/14/2014

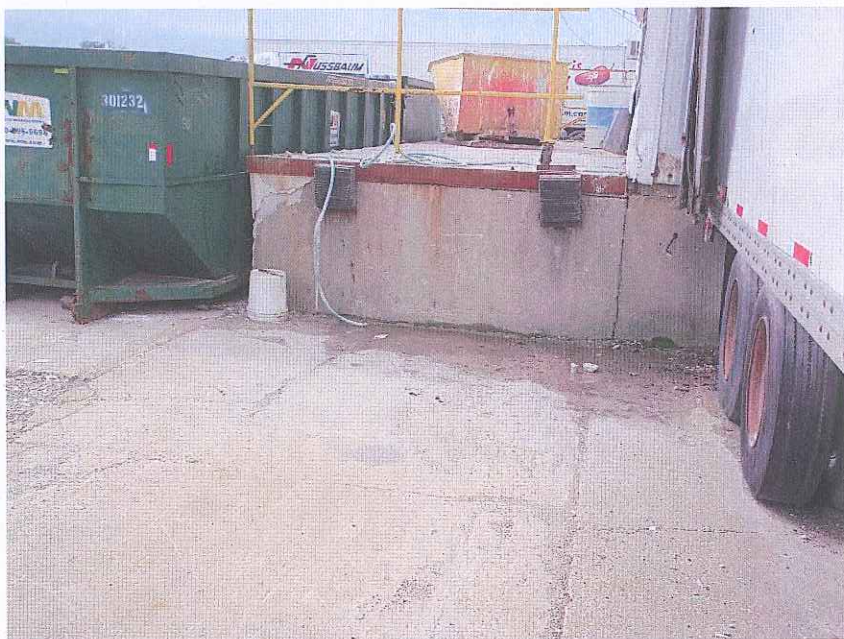
69: P1010308 Description: Hose from inside loading dock with water flowing out. IMC personel stated that water was from the fire sprinkler system. Location: East side loading dock. Direction: South.
Date: 5/14/2014
